EARTHWORKS SUMMARY REPORT
CAPESTONE ESTATE – STAGE 2A(2)
LOT 139

EARTHWORKS SUMMARY REPORT
CAPESTONE ESTATE – STAGE 2A(2)
LOT 140

EARTHWORKS SUMMARY REPORT
CAPESTONE ESTATE – STAGE 2A(2)
LOT 141

EARTHWORKS SUMMARY REPORT
CAPESTONE ESTATE – STAGE 2A(2)
LOT 146

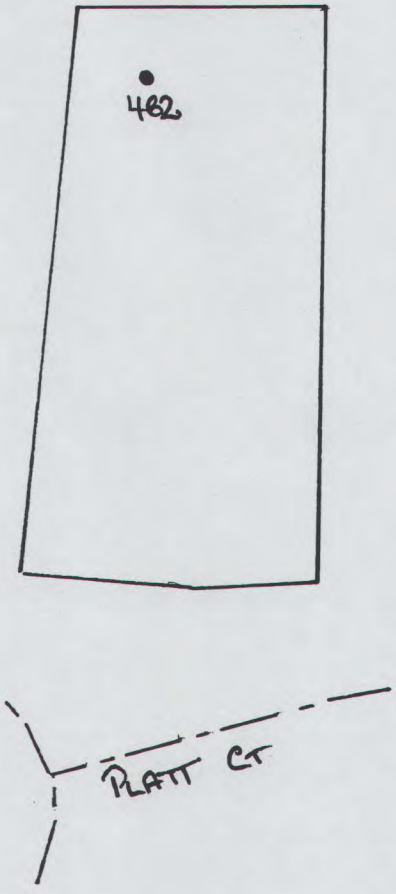
Test No.	Date Tested	Test Location	Dry Density Ratio AS1289 5.4.1 (Standard)
482	6.2.13	o/s 3m Rear bdy, o/s 5m Left bdy. R.L.7.51.	99.0

In our opinion fill on Lot 139 has been placed in a controlled manner to achieve a minimum dry density ratio of 95% to (AS1289.5.1.1 Standard Compaction). We confirm that filling to design final level can be termed controlled filling in accordance with Section 6.4.2. of AS2870-2011, via a "Level 1" inspection and testing commission.

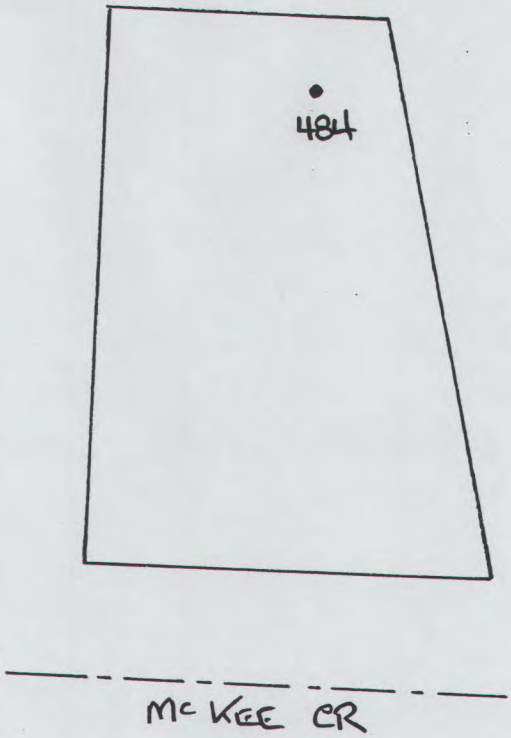
Test No.	Date Tested	Test Location	Dry Density Ratio AS1289 5.4.1 (Standard)
484	6.2.13	o/s 3m Rear bdy, o/s 5m Right bdy. R.L.7.70.	96.5

In our opinion fill on Lot 140 has been placed in a controlled manner to achieve a minimum dry density ratio of 95% to (AS1289.5.1.1 Standard Compaction). We confirm that filling to design final level can be termed controlled filling in accordance with Section 6.4.2. of AS2870-2011, via a "Level 1" inspection and testing commission.

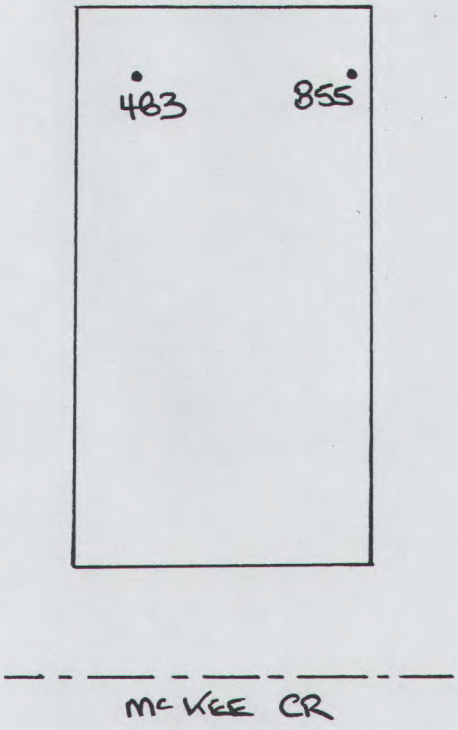
Test No.	Date Tested	Test Location	Dry Density Ratio AS1289 5.4.1 (Standard)
483	6.2.13	o/s 3m Rear bdy, o/s 3m Left bdy. R.L.7.14.	97.0
855	4.10.13	o/s 3m Rear bdy, o/s 1m Right bdy. R.L.7.84.	96.5

In our opinion fill on Lot 141 has been placed in a controlled manner to achieve a minimum dry density ratio of 95% to (AS1289.5.1.1 Standard Compaction). We confirm that filling to design final level can be termed controlled filling in accordance with Section 6.4.2. of AS2870-2011, via a "Level 1" inspection and testing commission.

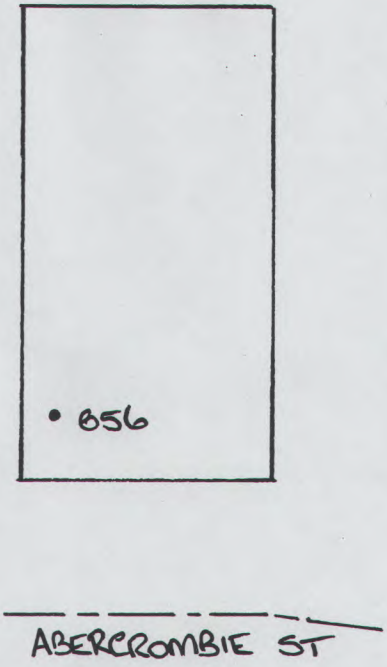
Test No.	Date Tested	Test Location	Dry Density Ratio AS1289 5.4.1 (Standard)
856	4.10.13	o/s 4m Front bdy, o/s 2m Left bdy. R.L.6.90.	95.5

In our opinion fill on Lot 146 has been placed in a controlled manner to achieve a minimum dry density ratio of 95% to (AS1289.5.1.1 Standard Compaction). We confirm that filling to design final level can be termed controlled filling in accordance with Section 6.4.2. of AS2870-2011, via a "Level 1" inspection and testing commission.

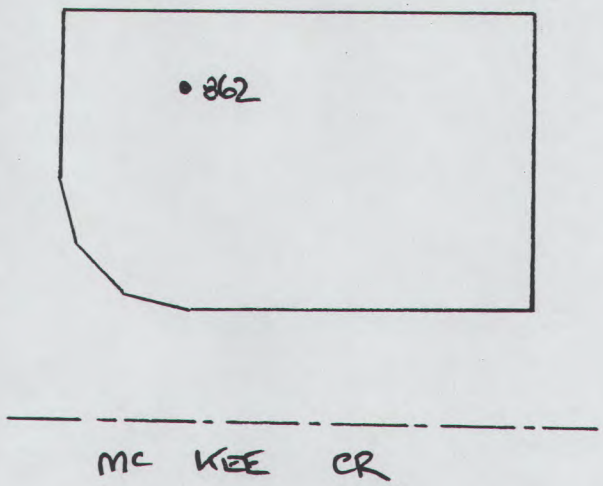
Test No.	Date Tested	Test Location	Dry Density Ratio AS1289 5.4.1 (Standard)
862	8.10.13	o/s 5m Front bdy, o/s 4m Left bdy. R.L.7.02.	98.0

In our opinion fill on Lot 147 has been placed in a controlled manner to achieve a minimum dry density ratio of 95% to (AS1289.5.1.1 Standard Compaction). We confirm that filling to design final level can be termed controlled filling in accordance with Section 6.4.2. of AS2870-2011, via a "Level 1" inspection and testing commission.
